Building Retro-Commissioning Picture Show Part 2

Svein Morner, P.E., Ph.D.

Sustainable Engineering Group LLC

Region VI Chapter Regional Conference (CRC) 2007

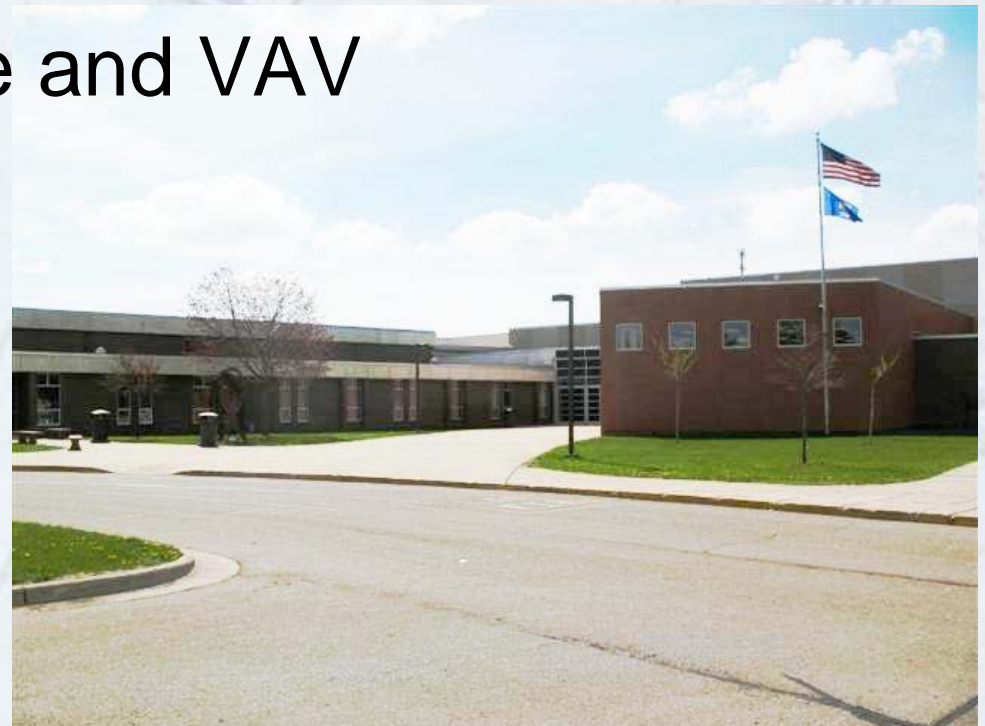
- Built in 1960's
- Several additions in 1980's and 1990's
- Total area of 250,000 ft²
- 30 Air Handling Units
- Mix of Constant Volume and VAV
- 7 Boilers and 2 Chillers

Main concern is
energy consumption

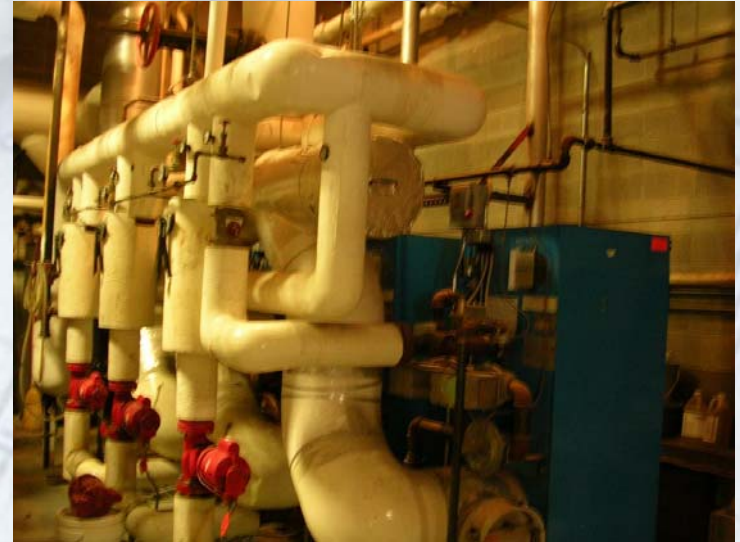
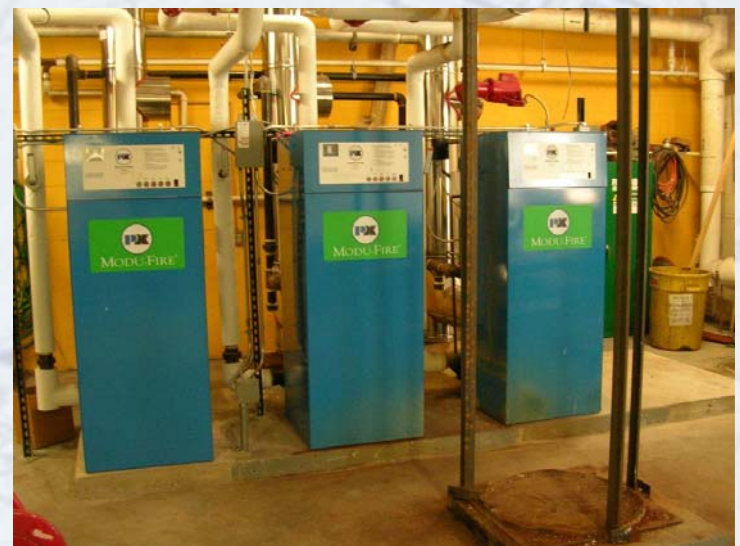
- A heating system controller was installed to allow for proper sequencing of all boiler units.
- The hot water system has been modified to allow for variable flow operation.
- Schedules have been modified to reflect space occupancy patterns for each air-handling unit zone.
- Economizer modes have been modified to improve comfort and energy efficiency

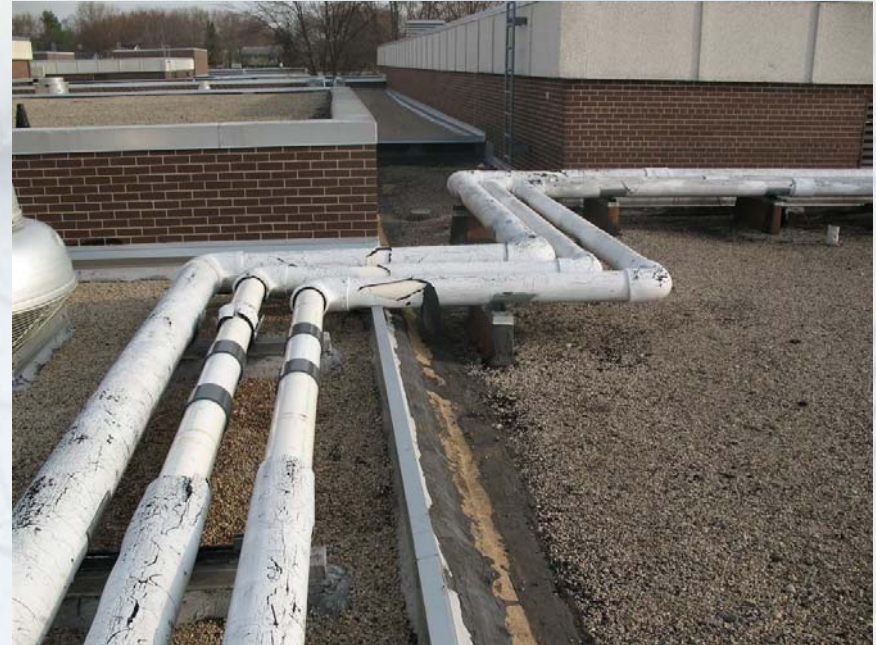
- Existing roof-mounted chilled water pipe insulation is badly deteriorated
- It is being replaced with thicker aluminum shielded, weather-resistant insulation

Savings due to improved insulation

OLD	NEW
Electric Use (kWh)	11,000	1,900
Electric Demand (kW)	18	3

Savings of about \$500 / year

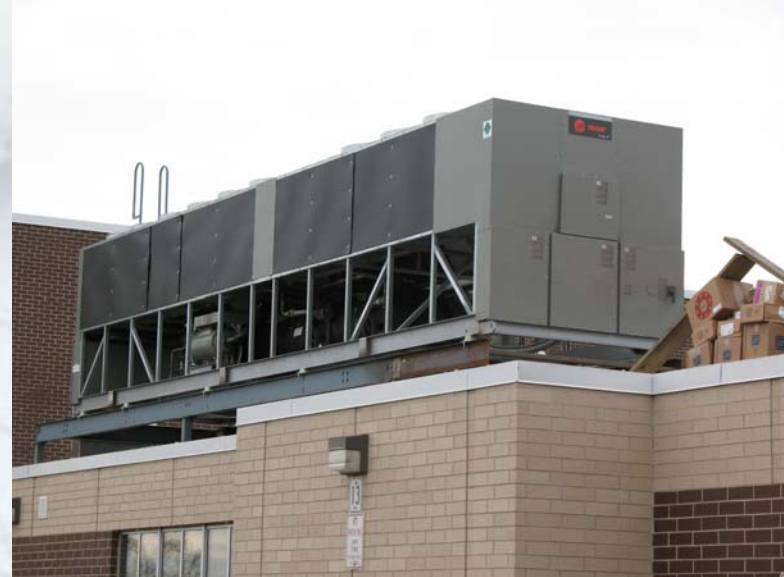
New

- Existing chillers are being replaced with more efficient and smaller capacity models that have variable speed drive pumps.
- Computer labs and the IT room have been removed from main chilled water system and are now cooled by independent cooling units, *which results in a shorter seasonal operating window for the chillers.*

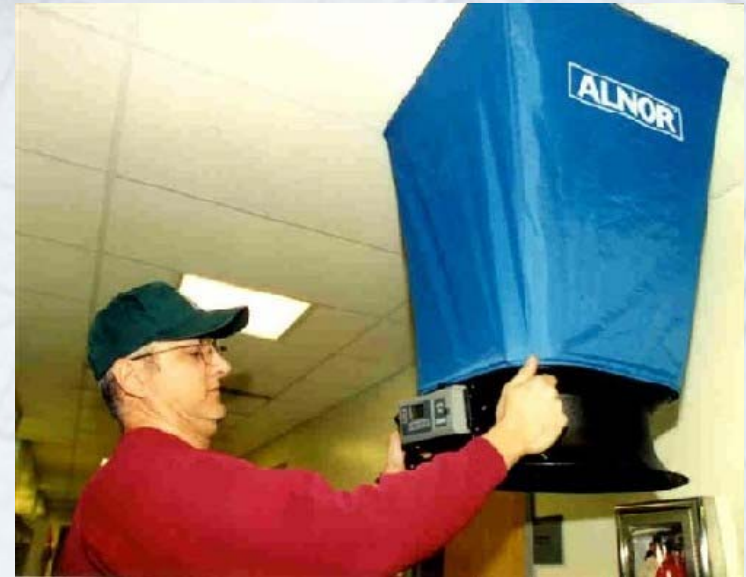
- Staff have reported problems with “stiffness” in several spaces
- Perimeter areas of Office and Guidance spaces too cold in winter

Airflow checking and rebalancing results in enhanced occupant comfort and potentially lower operating costs

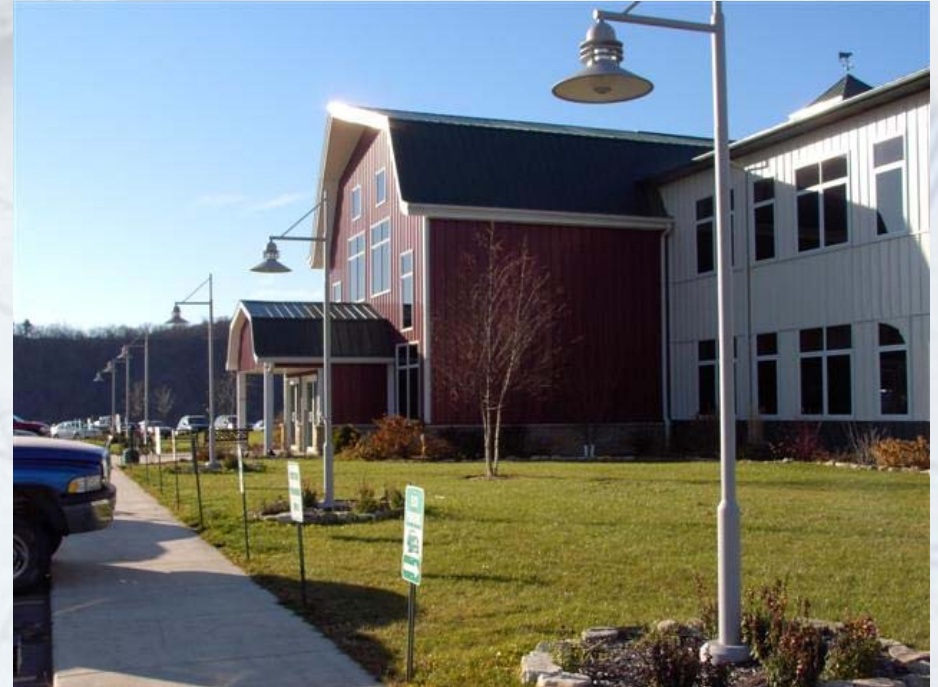
- Built in 2004
- 50,000 ft²
- 35 Water Source Heat Pumps
- Cooling Tower and Boilers
- Above average energy consumption (\$1.13 / ft² / year)

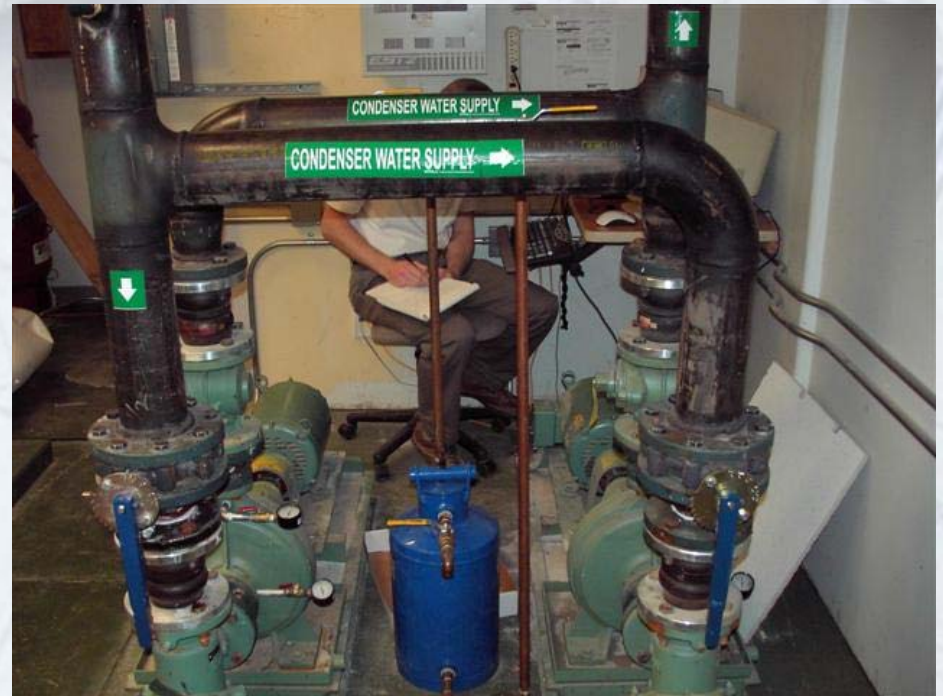
- Both circulating pumps running
- Design drawings refer to each as being sized for 100% load.
- Modify control sequence to bring on 2nd circulating pump only when needed.

By turning off one pump:

7.5 hp: 5.59 kW x 12 hr x 365 days = ~25,000 kW-hr /year : ~\$1,225 /yr

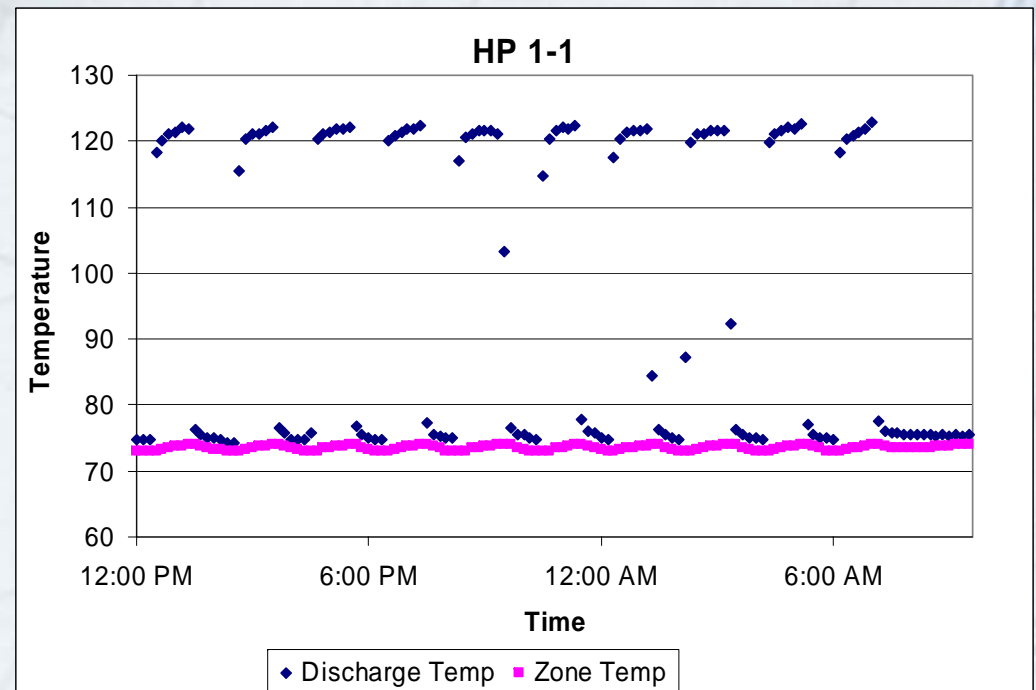
- A heat pump was observed to have discharge temperatures of 120° F
- High discharge temperature could indicate a faulty sensor, or low air flow among other causes.
- Investigate further with controls contractor.

More efficient system operation and reduced running costs

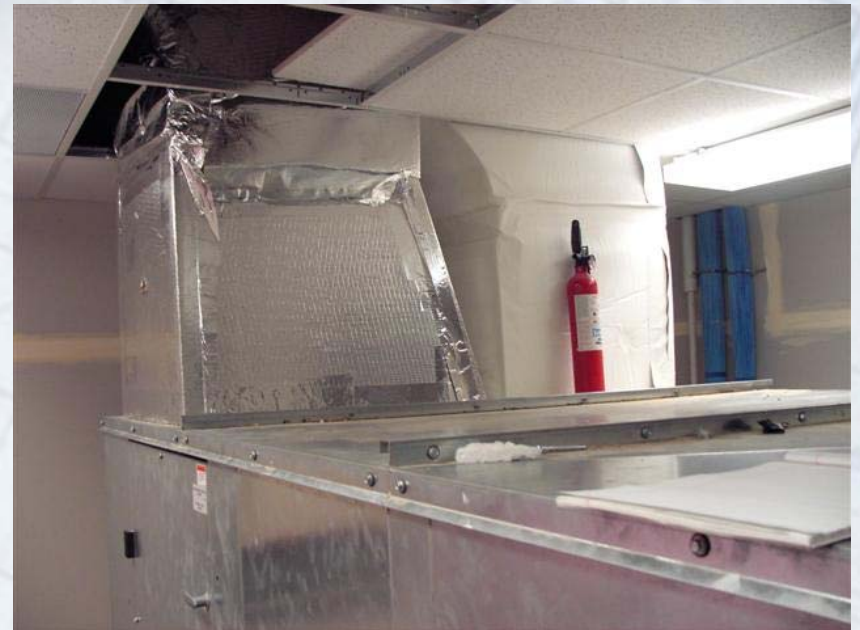
- Winter schedule has complete HVAC system running 24/7
- The controls sequence should be modified to include a night setback mode that has the ERU in unoccupied status and only 1 circulating pump on
- The heat pumps can be brought up to load in a staged manner in the morning to reduce peak consumption

Potential savings on the order of \$7,000/year

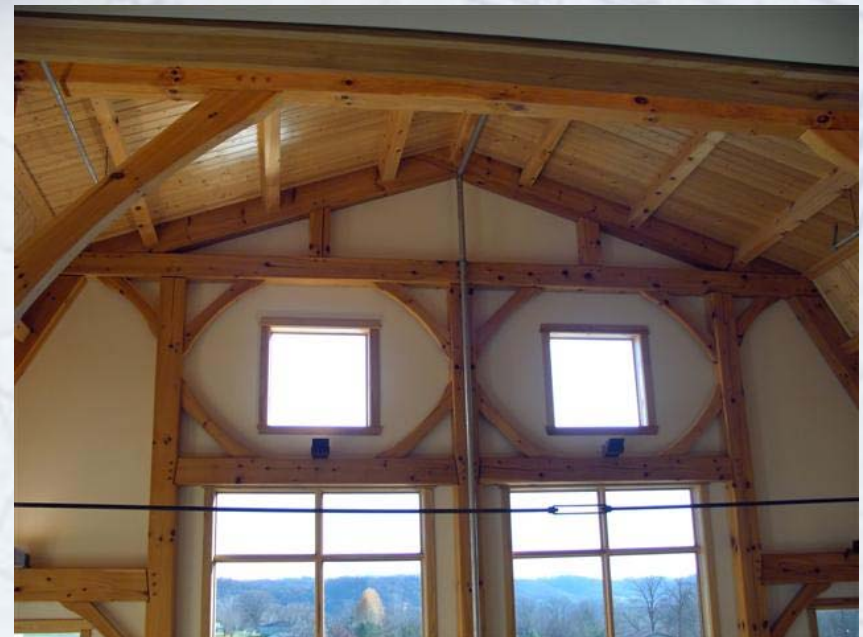
- In several areas of the building the occupants indicated that they feel cold drafts.
- Select areas of the building have been noted by occupants as having indoor air quality issues

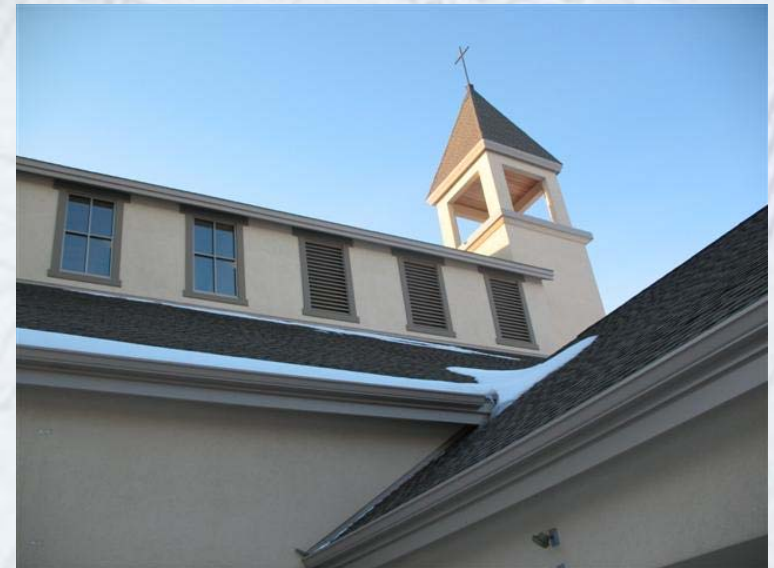
- The facility uses 808,596 kBtu of energy per year. This equates to 74 kBtu/ ft²/year.
- The average consumption for a similar facility in the mid-west is 53 kBtu/ ft²/year.
- This facility uses 33% more than average → i.e. there is a potential to save energy
- 33% reduction in gas and electric consumption will result in a savings of **\$4,200 per year**.

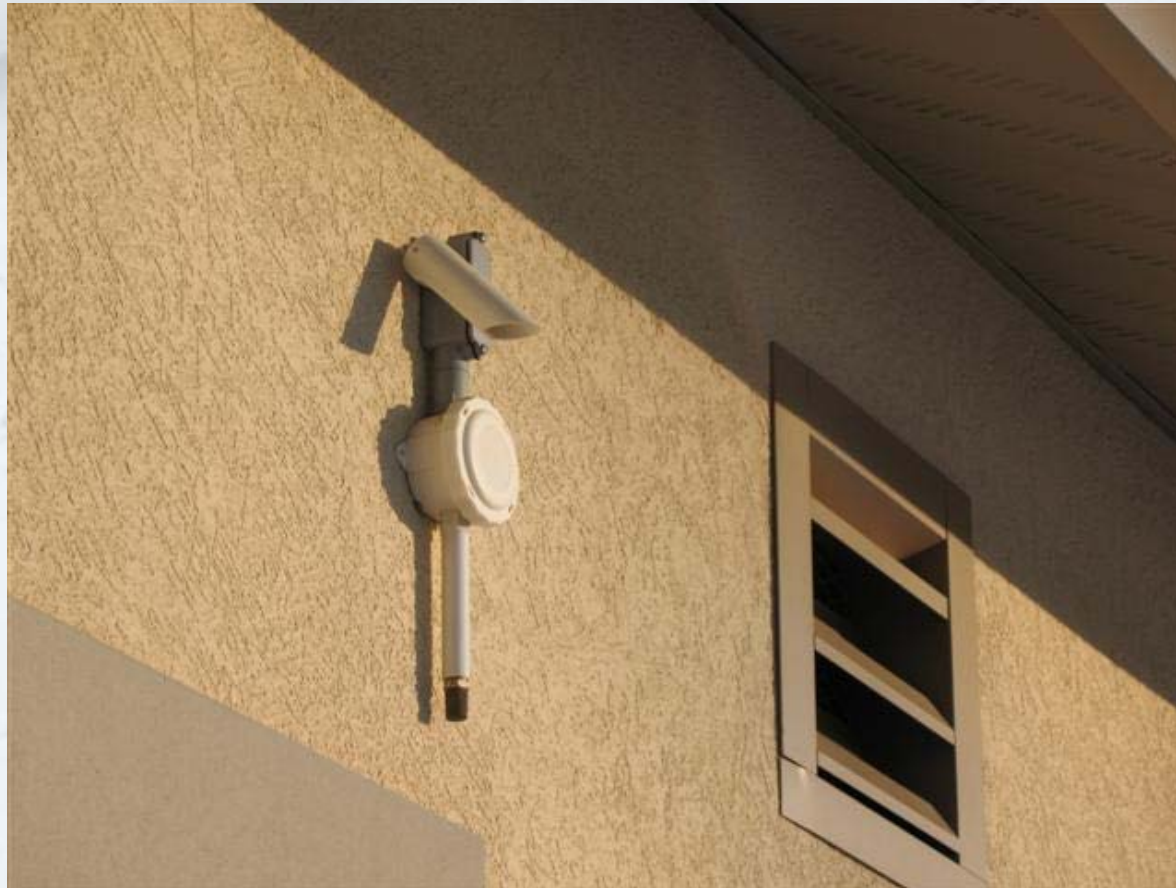
- During the early afternoon we observed the outside air temperature reading to the BAS to increase to 42°F even though the ambient temperature remained at 18°F.
- Possible solutions:
 - Sensor out of calibration?
 - Sensor located in warm spot?
 - Other.....
- Action:
 - Take a look at the sensor location

- OA Temp sensor located on West Wall

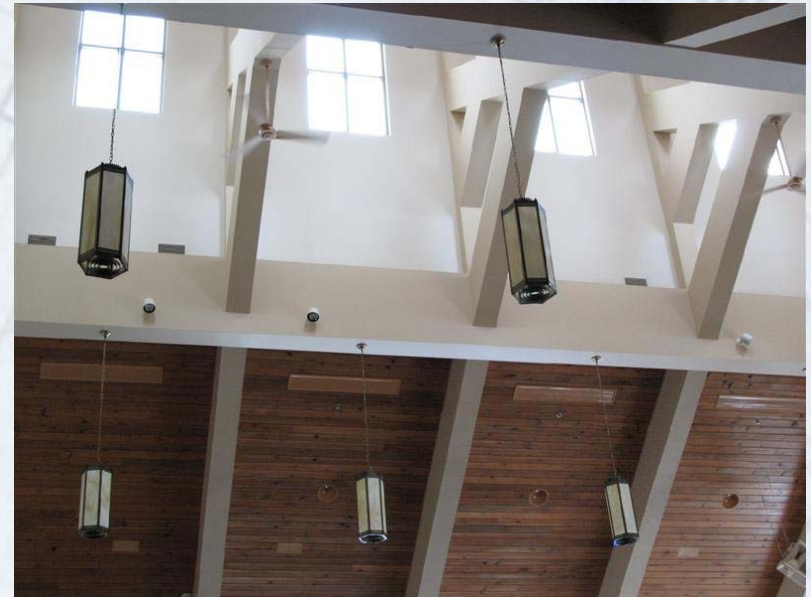
- Unable to maintain design temperature at seat level in the Nave.
- Possible solution:
 - Not enough heating capacity?
 - Too low airflow?
 - Stratification?
 - ???

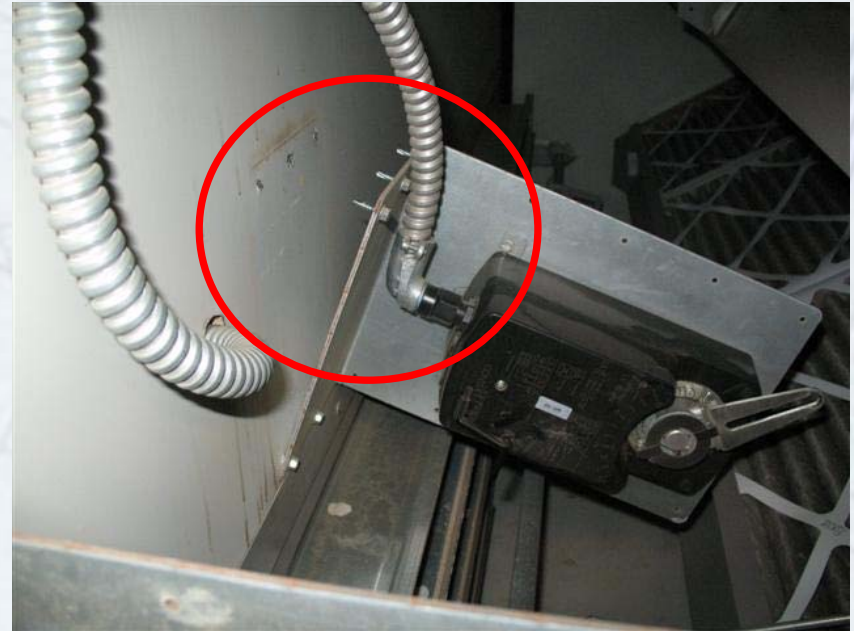
- The return air damper actuator had separated from its anchoring point on the air-handling unit casing.
- This had resulted in the return air damper being in the permanently closed position.
- After reattaching the damper to the unit casing we observed that the Nave and Gathering spaces were warmed up in a relatively short period of time.

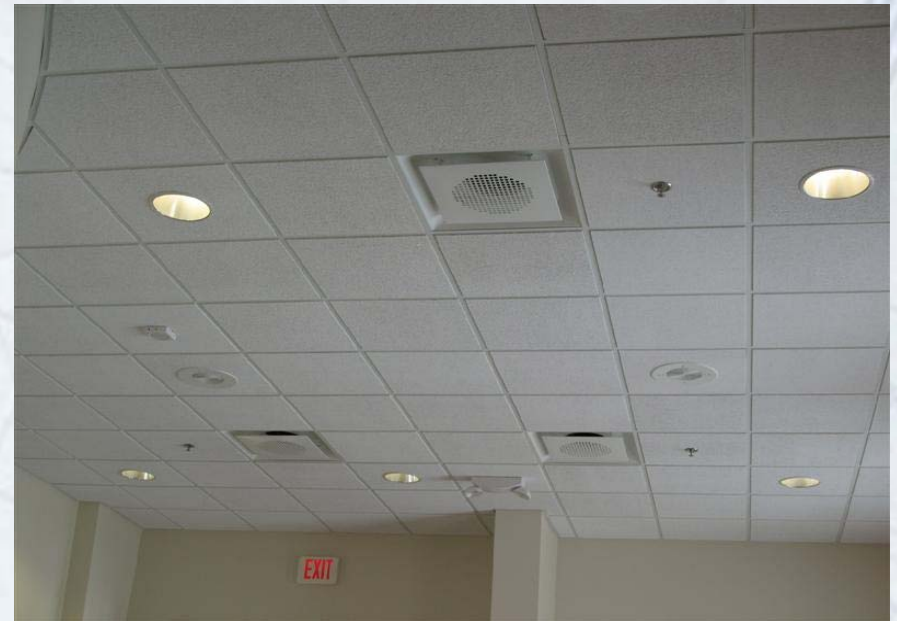
- The HVAC system was not able to maintain design temperatures
- With an outdoor temperature of 14°F the indoor temperature averaged 64°F while the hot water booster coil serving this area was at 100% of water flow.
- The high ceiling space and resulting stratification requires careful consideration of the diffuser selection in this space.

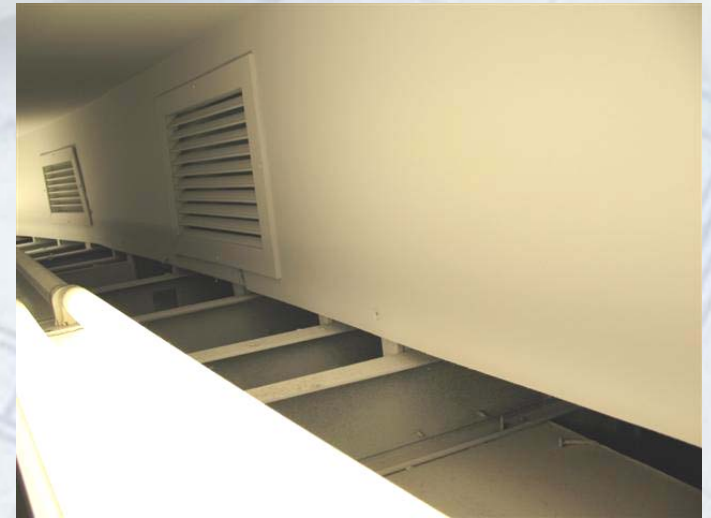
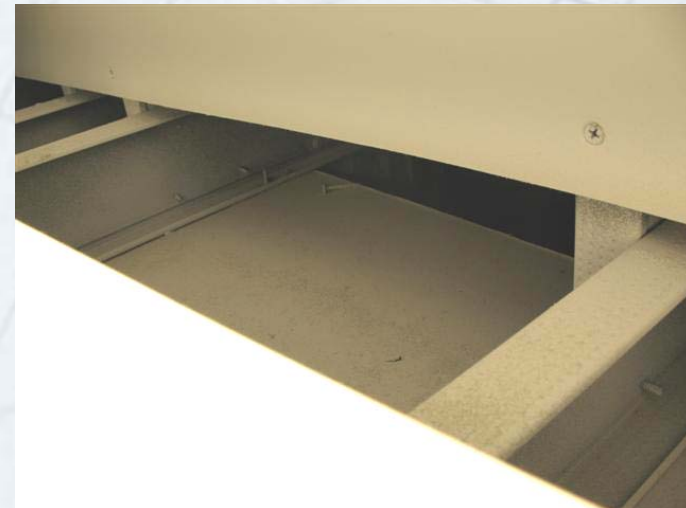
- A gap of 4-5" was noted in the oval soffit at the Transition Space
- A significant portion of the supply air was short circuiting the room and entering directly into the return air plenum.

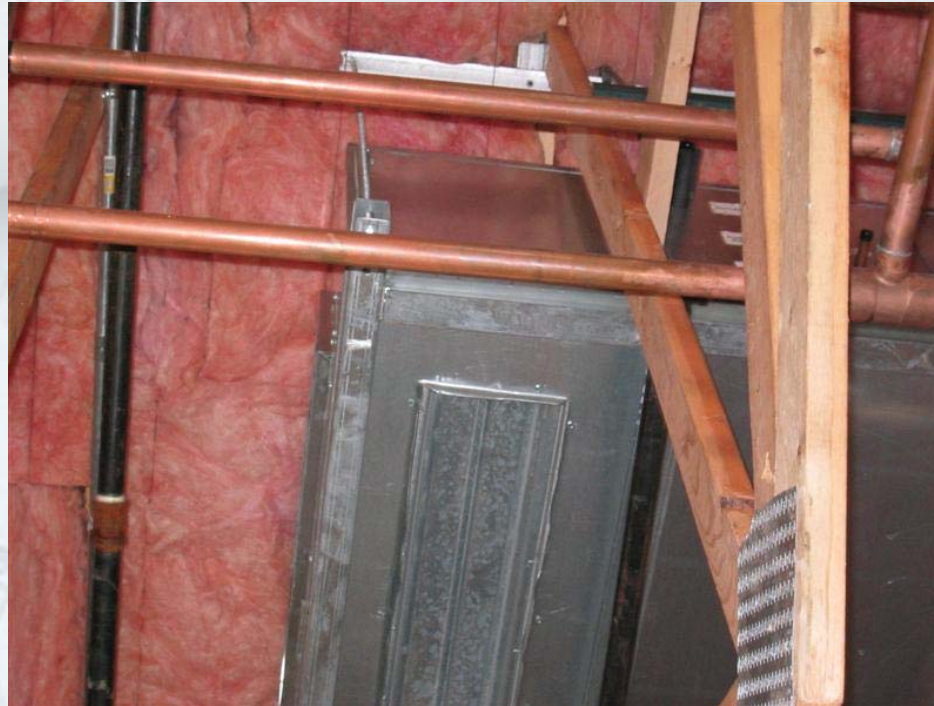
The filter access panel for the ceiling-mounted horizontal fan coil unit is obstructed by the wood trusses.

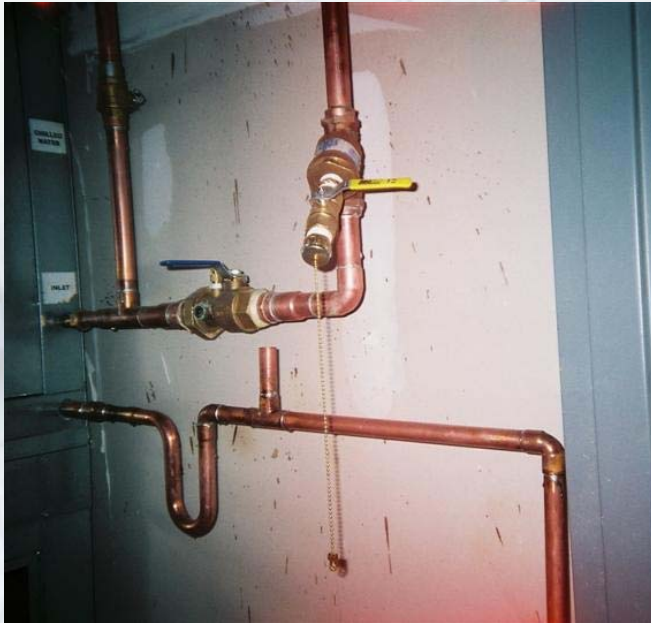
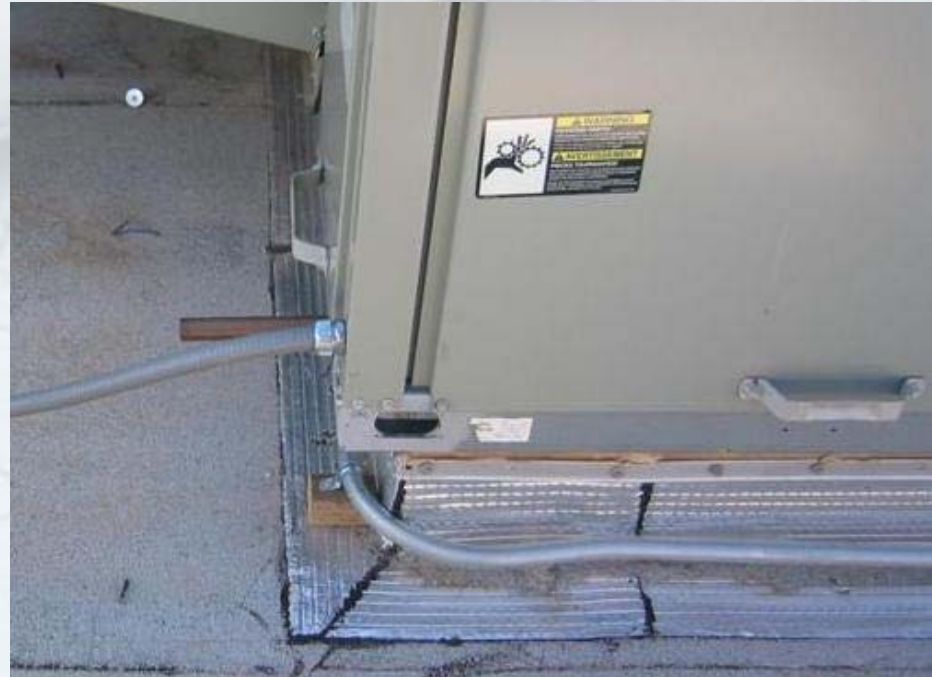
Condensate traps at the fan coil units are incorrectly installed.
Condensate traps at RTU units not installed

With the installation as above the condensate will back up in the cooling coil drain pan and overflow into room/RTU

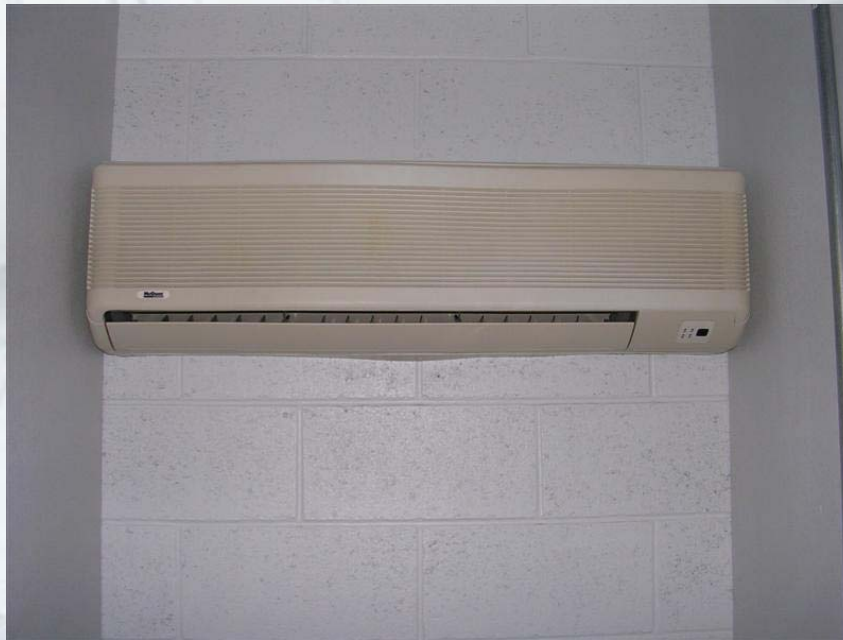
Ductless mini-split units have been installed with minimal clearance at either side.

Manufacturer's installation instructions recommends 2" minimum on both left and right sides.
